# **Environmental, Safety & Security Sequential Safety Meeting**

**ANACORTES REFINERY**

# PSE1 MPC PROCESS SAFETY ADVISORY

## GALVESTON BAY REFINERY SOUR WATER TANK FIRE INC# 409438

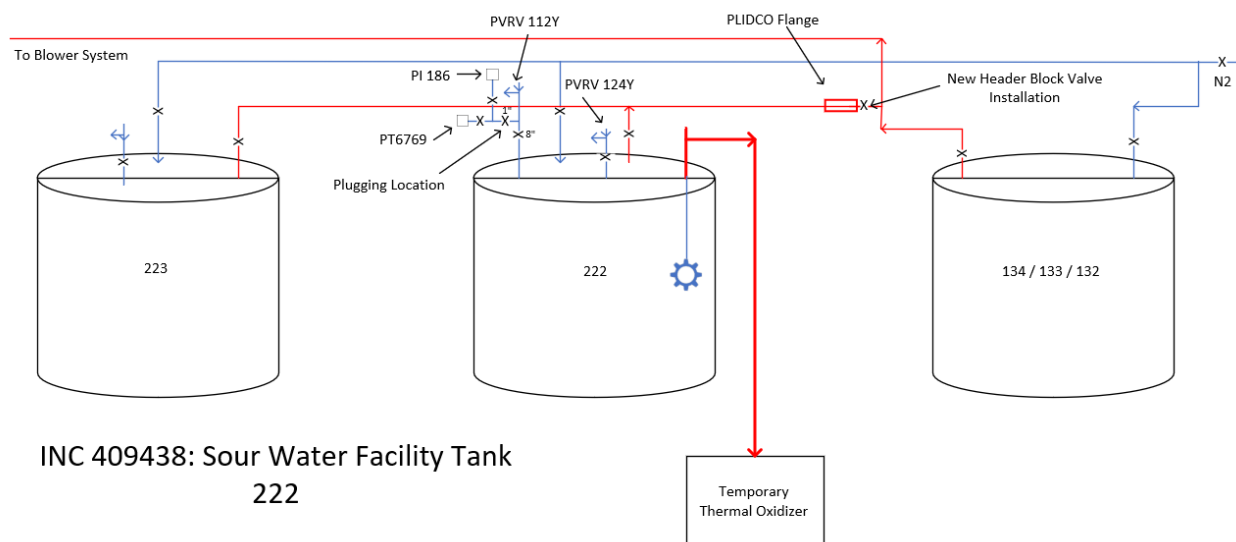
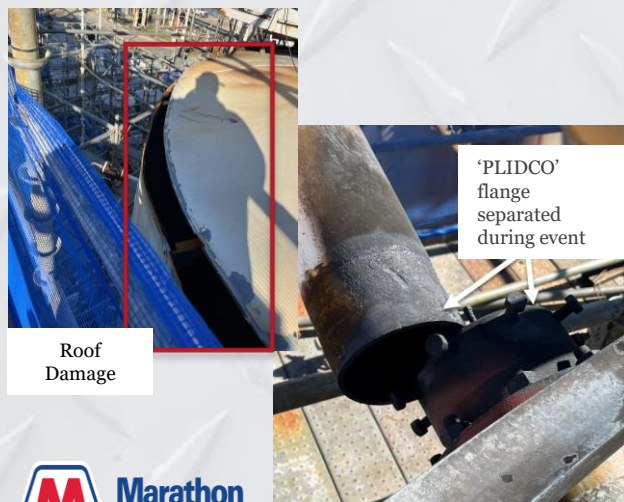
INC 409438: Sour Water Facility Tank 222

On December 13, 2023, while preparing GBR Sour Water Tank 222 for a maintenance outage, an explosion occurred when air was inadvertently introduced to the tank through a vacuum relief device. Damage occurred to the tank roof and separated a clamp-on 'PLIDCO' flange on a common vent pipe from the other sour system tanks. This resulted in a fire and vapor release to atmosphere.

- The nitrogen blanket supply to the tank was inadequate due to unknown plugging in the 1" common vent line connection to tank pressure transmitter, nitrogen control valve sensing line, and the manual pressure gauge.
- A work order was created to address the faulty pressure transmitter readings, but the work priority was not elevated as required (per RSP-1330-000 Operating Limits) for the Critical Process Variable (CPV) instrument.
- Operating procedures did not exist for removing sour water tanks from service.
- The cleanout guideline did not include a step to verify pyrophoric material was neutralized before switching from unit vapor recovery mode to atmospheric venting through a temporary thermal oxidizer.

**“THE REST OF THE STORY”:** In the months leading up to event, Operations identified faulty spurious readings from the Tank 222 pressure transmitter. Following troubleshooting, work orders were created and planned to calibrate and unplug the transmitter, but the work was not prioritized as Emergency, as required for CPV instrumentation. Unknown to Operations, the 1” vent line was plugged, which impacted the tank pressure transmitter readings, nitrogen blanket pressure regulator, and local pressure gauge. A common sour water tank vent system allowed the tank pressure to remain in normal operating ranges because the connected tanks’ pressure control systems worked correctly. During the vapor removal process, tank pressure was monitored via the DCS by Operations to ensure Tank 222 did not pull a vacuum. Preparation of the tank for maintenance included chemical treatment for pyrophoric material, but neutralization testing was not performed prior to routing vapor away from the common vent system to a thermal oxidizer. After Tank 222 was switched from normal operation using the common vent header to vapor routing through a blower to a thermal oxidizer, an explosion occurred—likely caused by a drop in tank pressure and subsequent air ingress through a vacuum breaker, which allowed un-neutralized pyrophoric material to auto-ignite.

| Recommendations | Assigned to: | Due Date: |
|---|---|---|
| Update SP-42-20 Tank Blanketing to include steam/heat tracing the vapor lines (including pilot lines) with a system that will keep the walls of the entire piping circuit greater than 212°F to prevent condensation of water vapor on the inside of the pipe for tank blanketing systems to a closed vapor recovery system on tanks with high H2S concentrations in the vapor space (i.e., Sour Water Tanks). | Brad Martin | 9/30/2026 |
| Develop procedure for taking a Sour Water Tank out of service. Include steps for pyrophoric neutralization and transitioning tank to air. Review with Tank Technologist. | Operations/Product s Directors | 9/30/2026 |
| Update SP-50-34 to add limitations for the use of ‘PLIDCO’ bolt on type fittings. | Mike Alford | 9/30/2026 |

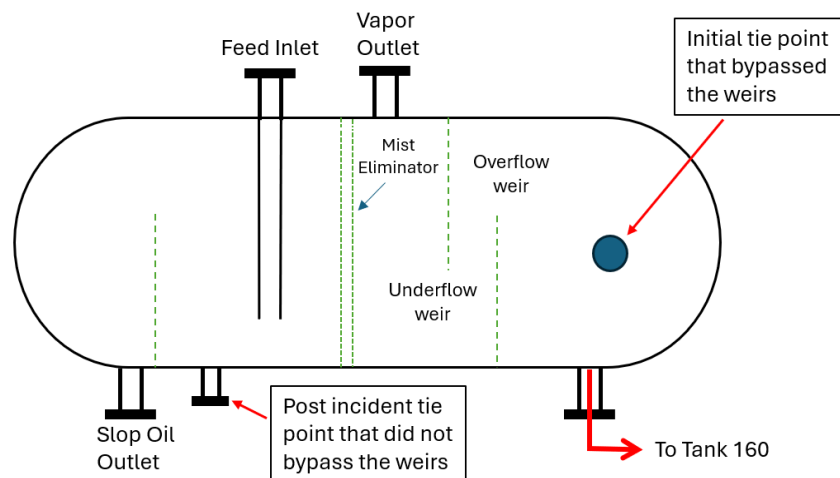
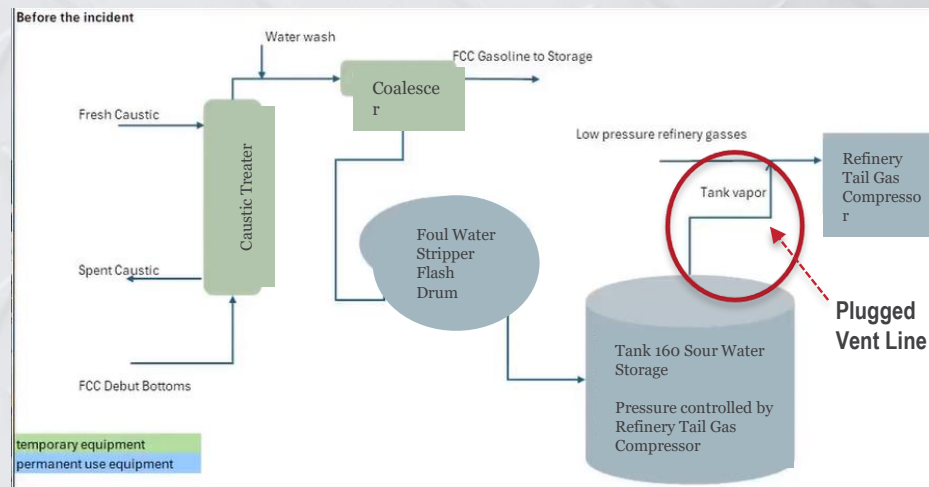
Foul Water Stripper Flash Drum

On September 14, 2024, the rupture disc on Sour Water Tank 160 burst and released to the atmosphere. Personal and fixed gas H<sub>2</sub>S monitors began to activate. Tank 160 nitrogen blanket flow could not restore pressure, so draw from the tank was reduced to prevent air ingress. Just prior to the release, a temporary FCC gasoline treating system had been started up. Due to a design issue, FCC gasoline was routed to the tank causing the high pressure.

- Design of the temporary coalescer water boot routed to water side of flash drum preventing oil and water separation prior to pumping to Tank 160.
- Tank 160 vent line to the tail gas compressor was determined to be plugged.

**“THE REST OF THE STORY”:** In 2019, the FCC gasoline treater and precipitator were removed from service due to no longer being needed for sulfur removal of FCC gasoline and concerns with caustic carryover from the treater. A planned outage of the Gas Oil Hydrotreater (GOHT) unit, which supplies low sulfur gas oil to the FCC, was planned for September 2024. The scope freeze for the scheduled GOHT catalyst change was September 2023, and the plan for sulfur treatment had not been set. In May 2024, Sequence of Event (SOE) for GOHT shutdown review highlighted product quality sulfur concerns. The Area Team began evaluating sulfur treatment options. On August 14, the team began designing a treatment system which included the FCC gasoline treater and wash water with redundant coalescers to remove entrained caustic. A flaw in the design routed the coalescer water boot to the water side of the sour water flash drum preventing any oil and water separation prior to pumping to the foul water storage Tank 160. On September 14, the treatment system was placed into service. Soon after, the level and pressure in Tank 160 began to rise and the tank vent control valve reached 100% output. Several hours later, the FCC Console received a high-pressure alarm that went unnoticed and remained active throughout the day. There was no conversation about the standing alarm during shift turnover and soon after tank pressure reached 4.5 PSI, the rupture disc burst, and released the vapor space of the tank to atmosphere. Post incident the vent line was identified as plugged with material that is suspected to be a sulfur oxide.

**\*Recommendation included in GBR Global Recs in previous slide\*** Update SP-42-20 Tank Blanketing to include steam/heat tracing the vapor lines (including pilot lines) with a system that will keep the walls of the entire piping circuit greater than 212°F to prevent condensation of water vapor on the inside of the pipe for tank blanketing systems to a closed vapor recovery system on tanks with high H<sub>2</sub>S concentrations in the vapor space (i.e., Sour Water Tanks).
