Environmental, Safety & Security Sequential Safety Meeting

ANACORTES REFINERY

**Debutanizer Feed Line Pinhole Leak:
Abrasive Blasting on Live Equipment
B-Zone – Gas Recovery**

**Cat 2 Investigation: Incident #507866
12/31/2025**

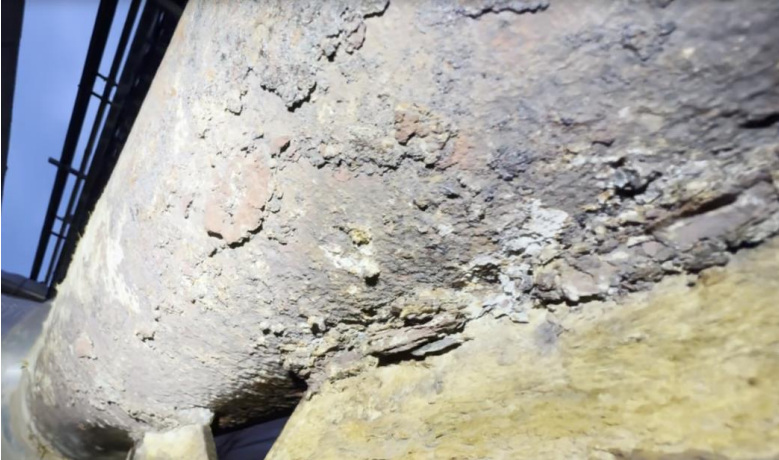
- Abrasive Blasting During Scale Removal Exposed a Through-Wall Defect Resulting in LOPC(Loss of Primary Containment)
 - Location of Failure Prone to Accelerated CUI(Corrosion Under Insulation) Attack
 - Inspection Hold Process Did Not Identify Pipe Wall Thickness Was Inadequate for Surface Preparation or Abrasive Blasting on Live Equipment
- ✓ Corrosion under insulation is progressive and often undetectable until advanced wall loss exists. Inspection programs alone cannot guarantee the prevention of loss of primary containment.
 - ✓ Pipe support shoes under mineral wool insulation represent an elevated risk and may require enhanced mitigation strategies.
 - ✓ Surface preparation on live equipment functions as a final barrier against loss of containment and must be managed as a higher-risk activity.
 - ✓ Rapid cross-functional response significantly reduces consequence severity

CUI scale can mask localized wall thinning

- **Rec 1:** Develop a procedure to outline requirements for surface preparation on in-service piping and equipment.

- **Rec 2:** Develop a strategy to conduct evaluations for CUI susceptible piping to determine the necessity for existing insulation systems.

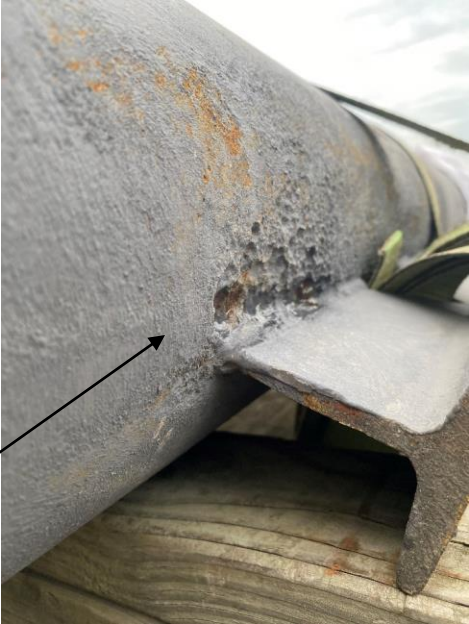
CUI damage on the nearby shoe was found to have greater than anticipated wall loss after blasting and primer coating.

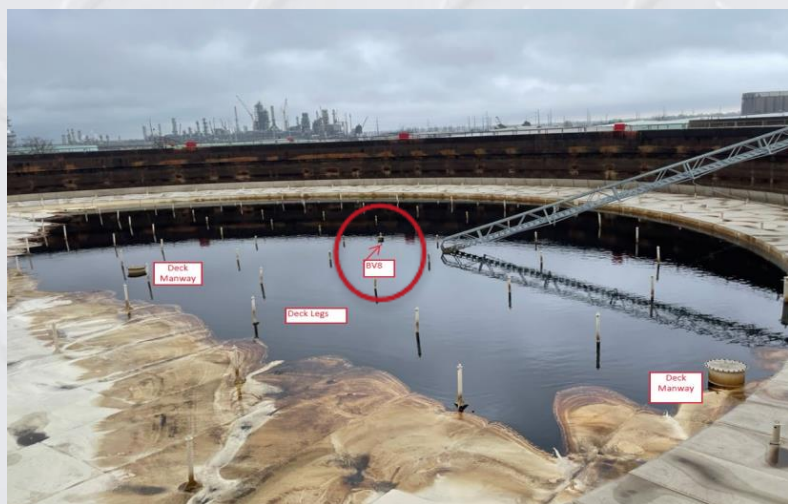
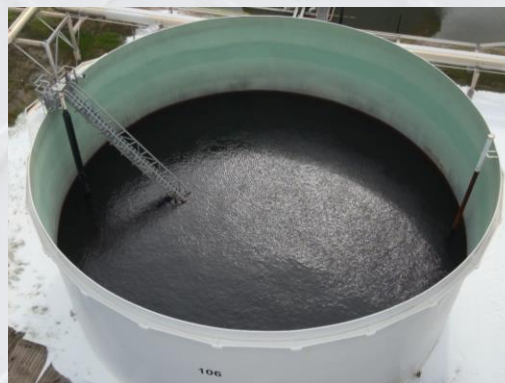
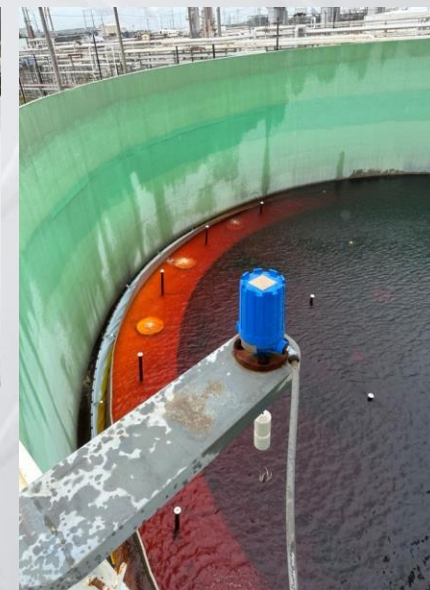
- Inadequate rainwater roof drainage on Tank 500-5 resulted in a severely deflected external floating roof near a bleeder vent, allowing crude oil from the tank to pass through the bleeder valve to the roof.

- Roof drain was believed to be obstructed, preventing a significant amount of rainwater from draining from the roof.

“THE REST OF THE STORY”: (GVL) Two weeks prior to the incident, during a seal inspection, it was noted that a 6-inch check valve associated with the tank roof drain was stuck closed. The inspector popped the check valve open to drain the water from the roof. On 1/25/2024, GVL experienced over 6.9” of rainfall. The check valve was again stuck in the closed position causing rainwater to accumulate on the roof. The deflection of external floating roof plates, caused by the accumulated rainwater, submerged a bleeder vent and allowed crude oil to get on top of the tank. GVL replaced the check valve with a new one the week following the January incident. In addition to the roof drain being compromised, a new tank roof was constructed in 2021 with an extra bleeder vent near the end of stairs that was shorter than the rest of the bleeder vents. On 4/10/2024, an even more significant rainfall occurred where rainwater again submerged this bleeder vent even though the roof drain worked properly. This April rainfall event was extraordinary with 2” in thirty minutes, more than 3” in one hour and more than 8” in six hours. Following this incident, GVL performed an MOC to cap/blind the bleeder vent.

(GBR) GBR experienced over 10” of rainfall in the week preceding the incident, and ~3.5” the day of the incident. The Tk-106 roof failure likely occurred at 10:18 a.m., when PI trends indicated an increase and decrease in level readings. At 2 p.m., Operations began dewatering a Raffinate tank to Tk-106. While completing the flow balance sheet for the dewatering activity, an Operator observed abnormal flow readings. Upon returning to Tk-106, the Operator observed that the roof had submerged, and product was flowing through the roof drain. Operations quickly mitigated the spill and contacted the GBR ERT for additional support. A thorough inspection of the tank identified no apparent mechanical failure of the structural elements of the tank. The investigation concluded that an obstruction in the roof drain system likely prevented effective draining of the roof, resulting in a seal failure.

Recommendations	Assigned to:	Due Date:
<i>Review this advisory with your leadership team and cascade to your entire organization to ensure site-wide review to improve process safety hazard recognition.</i>	Site VPs	5/31/2026
<i>For sites with external floating roof tanks, develop/ensure your site has a written policy or procedure that addresses the management of tank roof drain valves and includes the proper identification/mitigation/removal of water before/during/after heavy rain events.</i>	Operations/Product Control Directors	3/31/2027
<i>Update RRD-1148-000 Operator Rounds to include monthly round task details in accordance with API-653 and industry practices, including roof drain monitoring and valve exercising.</i>	Blake Luminais	9/30/2026
<i>Update SP-90-13 Aboveground Storage Tank Inspection Program to include standardized requirements for external floating roof inspection task details in accordance with API-653 and industry practices, including verification that roof drain sump and check valve are clear.</i>	Kenny Spriggs	9/30/2026

<i>Update site checklists to implement requirements per SP-90-13 for sites with external floating roof tanks.</i>	Maintenance Directors	3/31/2027
<i>Update SP-42-18 to include guidance on vacuum breaker installation locations. (Assigned as part of GVL Investigation Recommendation #341345)</i>	Kenny Spriggs	Complete
