# Environmental, Safety & Security Sequential Safety Meeting

**ANACORTES REFINERY**

# Incident Bulletin: Rigging Failure MPC-DET

## AFPM 1P Near Miss - Rigging Failure

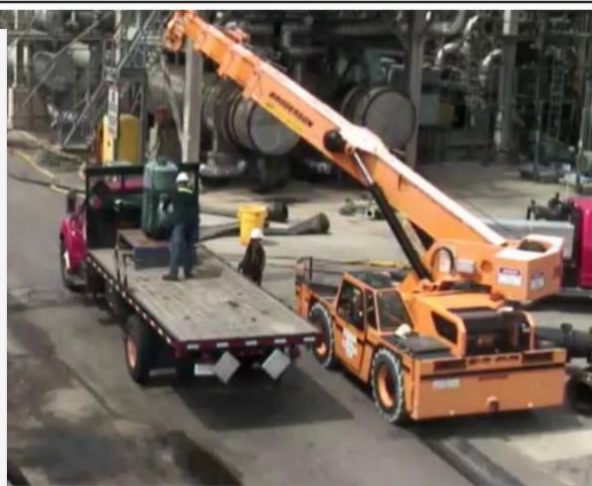
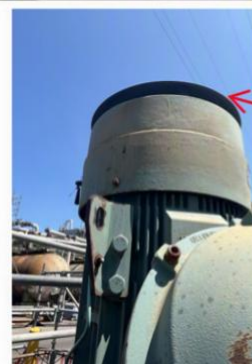
On July 31, 2026, MPC employees were tasked with removing Complex 1 storm water pump motor, 29P98A. After removing the motor from the pump and attaching it to a metal pallet, the motor/pallet assembly was moved via crane onto a flatbed truck. During the travel of the motor/pallet assembly from its original position to its final destination, the rigging was positioned so that it was in contact against the sharp edge of the motor rain shield, resulting in abrasions/damage to the rigging. While the motor/pallet assembly was being positioned into its final destination, the slings severed causing the assembly to fall approximately 4 inches to the surface of the flatbed truck. Initial investigation revealed that neither tag lines nor sling protectors were used during the movement of the motor/pallet assembly. Additionally, opportunities for barricade use and line of fire recognition were identified. These findings increased the severity potential of the event. No injuries resulted from the failure of the rigging. The combined weight of the motor/pallet assembly ~4,200 lbs.

Sharp edge of motor that caused rigging damage

Utilize spreader bars to avoid contact with sharp edges or strap softeners to prevent damage

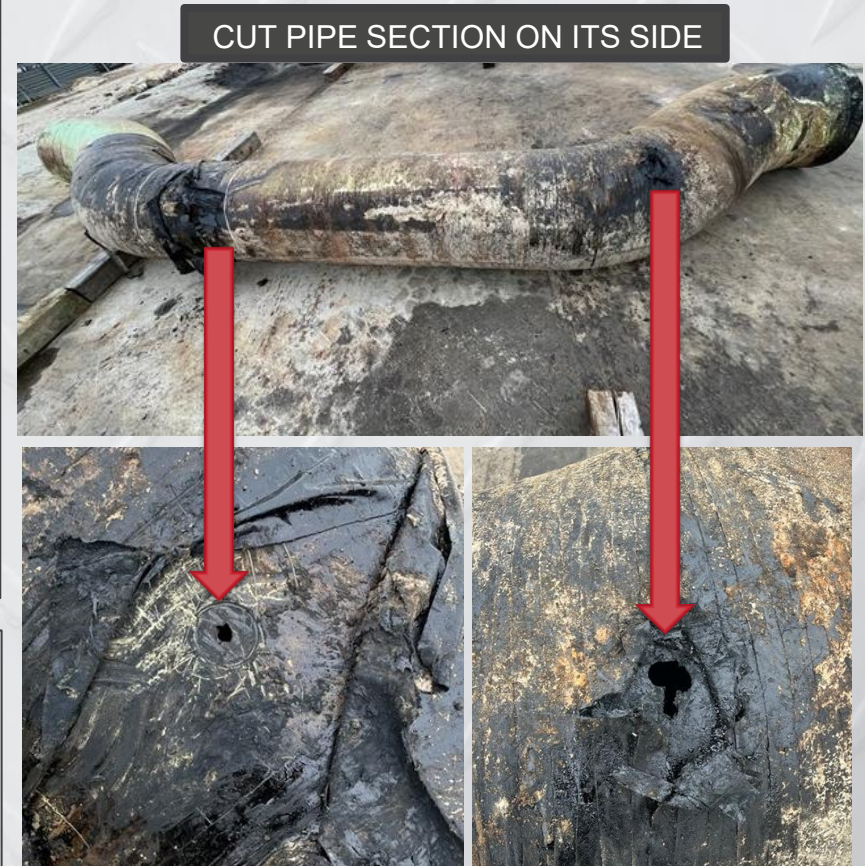
On January 17, 2024, Tank Farm Operators discovered crude oil in Tank 500-6 containment dike. The source of the leak was identified on the bottom of a pocketed piping circuit in intermittent service in the crude suction piping circuit. The line was isolated and deinventoried. The failed section was removed and placed on its side for inspection (pictured). This revealed two non-uniform holes in the bottom section, near the low point of the piping.

➤ Pocketed section of intermittently used crude piping line resulting in a combination of Microbiologically Influenced Corrosion (MIC) and low pH corrosion.

| Recommendations | Assigned to: | Due Date: |
|---|---|---|
| Identify pocketed sections of intermittently used piping with the potential for a similar damage mechanism, Microbiologically Influenced Corrosion (MIC), and update the inspection program for areas of concern (e.g., crude piping). Results from ITPM should drive additional action as needed. | Maintenance Directors | 7/31/2027 |

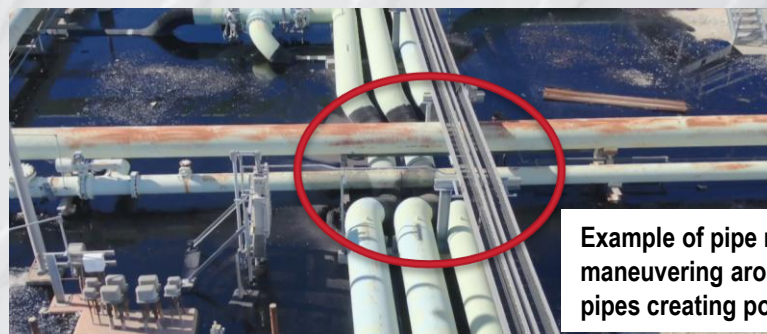
**“THE REST OF THE STORY”:** The tank farm crude charge system has had previous MIC failures in 2015 and 2021 in stagnant flow or pocketed areas. A prioritized list of at-risk lines were inspected using Guided Wave ultrasonic (GUL) inspection. The buried piping sections within these pockets were not inspected due to a combination of the above-ground inspection findings and GUL’s limited effectiveness in assessing buried piping. After the 2024 incident, pocketed piping circuits in intermittent service are being inspected. The site investigation team recommended developing an inventory of pocketed lines within the crude charge system and implementing an inspection program to assess their current condition. The team also recommended evaluating potential design or system modifications to reduce or eliminate this failure mode. Many of the pockets were created during a previous major expansion where pipe runs had to maneuver around existing pipes (see example picture below).

**Example of pipe runs maneuvering around existing pipes creating pocket**

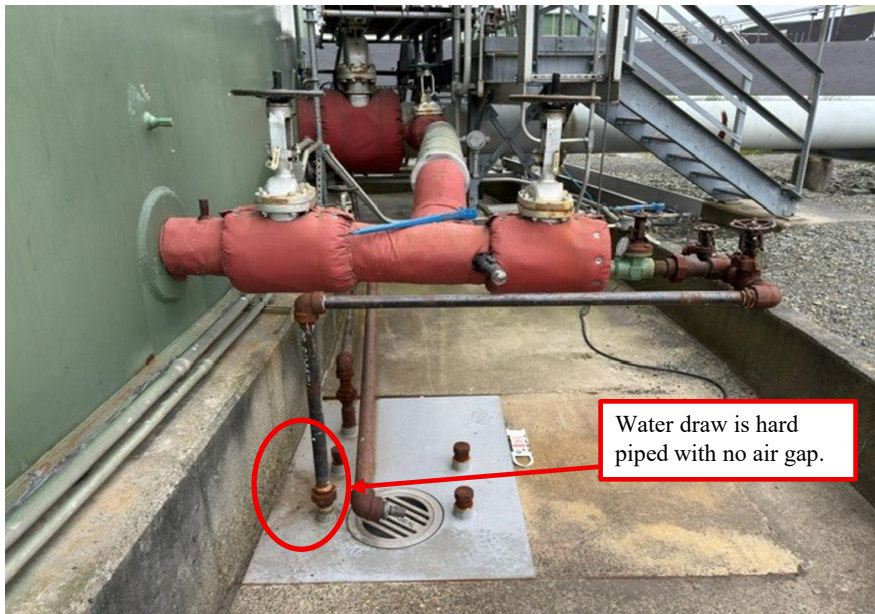
**Tank 203**

- Tank 203 is a Gasoline Tank
- Prior to the valve being found open, operations had been conducting extra microbiological samples
- The water draw configuration is atypical compared to other gasoline tanks.

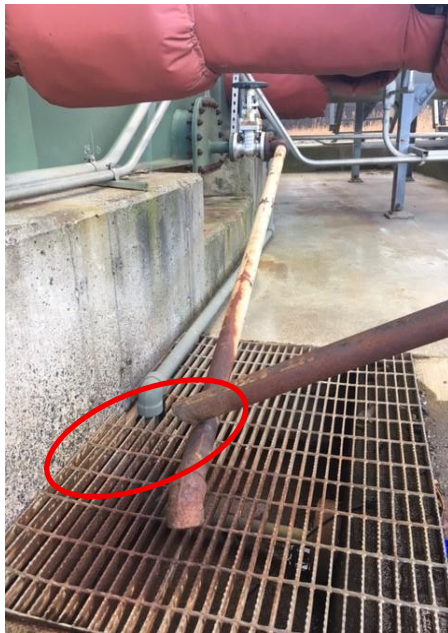
**Before**

Prior to 2024 the water draw piping arrangement on TK 203 had an air gap into an open sewer grate.

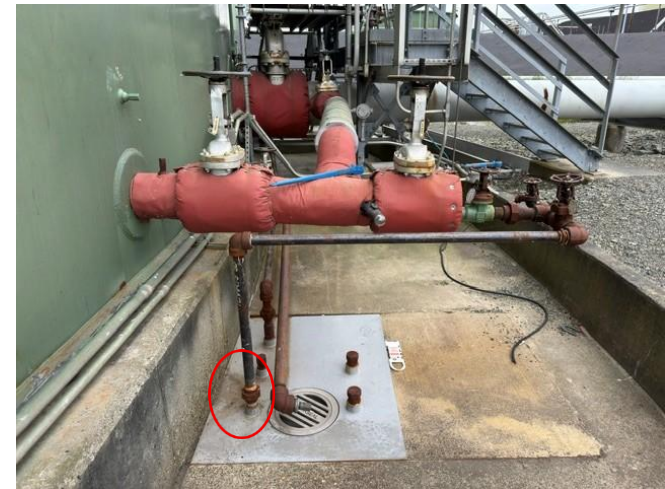
**After**

The tank water draw piping and water draw box were modified in July 2024 to include an N-Serta seal.

The addition of the N Serta seal also included modification of the piping to eliminate the Air Gap.

No MOC was conducted for this change

| Recommendation | Assignee/Target Date |
|---|---|
| Restore verification point to water draw piping | John Harrington; 11/1/26 |
