# **Environmental, Safety & Security Sequential Safety Meeting**

**ANACORTES REFINERY**

# PSE<sub>1</sub> MPC POST EVENT LEARNING REPORT

## GALVESTON BAY TRANSMITTER MANIFOLD LEAK INC# 461426

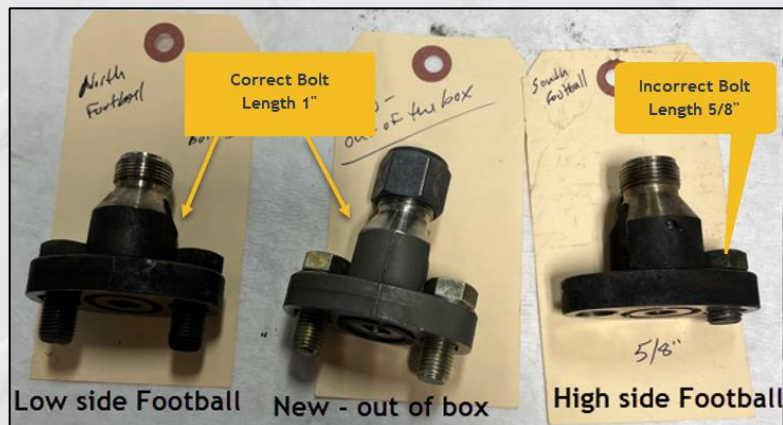
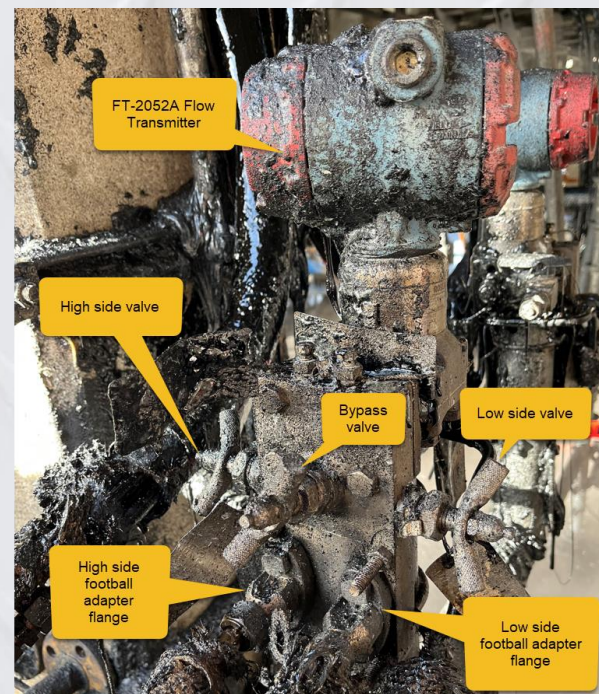
On January 16, 2025, a leak occurred on Flow Transmitter FT-2052A, which is on the inlet of the Resid Hydrocracking Unit (RHU) 200 train Hot Oil Heater 201-B, operating at 298opsi and 519°F. The leak of hot resid material occurred when an I.E. Technician noticed a small leak on the transmitter high side football adapter flange. When the technician placed a socket on the bolt it became loose, spraying resid. The technician was sprayed on the arm and face and received first aid treatment. Due to the proximity of the leak to the RHU 300 heater, Operations made the decision to shutdown both units.

➤ **This transmitter release was a PSE<sub>1</sub> due to the release of ~50 bbl. of combustible material released above flash point. This was also an AFPM 1P Significant Injury or Fatality (SIF) event. During shutdown, the RHU depressured to the flare which resulted in a Tier 3 DEI.**

- Post event analysis identified the wrong length bolt was installed on a football adapter flange, leading to the lack of thread engagement.
- There was no QA/QC specific verification question related to the bolt thread engagement of the football adapter flange to the manifold.

On January 16, 2025, an emergency work order was generated to calibrate the FT-2052A flow transmitter and pump glycerin into the impulse lines as needed. The I.E. Technician noticed a small glycerin leak on the high side football adapter flange and placed a socket on the bolt to verify the size when the bolt became dislodged, and the football adapter flange began leaking. Hot resid material at ~298opsi and 519°F sprayed the I.E. Technician on the arm and face. Operations shutdown the RHU 200 train and proactively began shutdown of the RHU 300 train due to the proximity of the leak to the running furnaces. The investigation identified the wrong length bolt installed on the football adapter flange, leading to the lack of thread engagement and LOPC.

- Update the QVD (quality verifying document) EI.70-001 Instrument QA/QC Inspection Checklist to specifically inspect the bolt/thread engagement of football adapter flanges with the instrument manifold. Complete per Rec# 369631.
