Environmental, Safety & Security Sequential Safety Meeting

ANACORTES REFINERY

Tank 231 Mixer Seal Leak(PSE2)

ST. PAUL PARK ASPHALT TANK ROOF DAMAGE INC# 390960

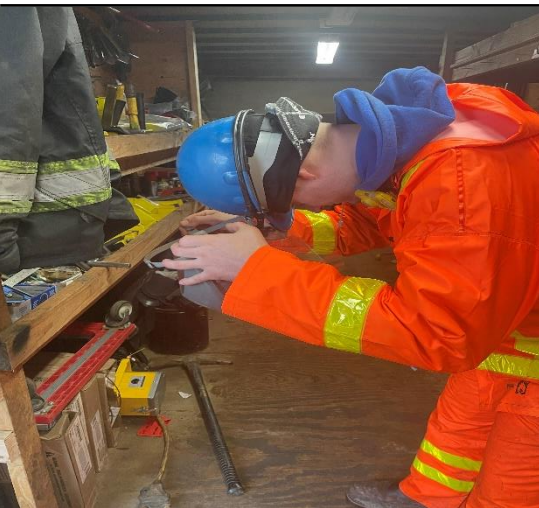
Removing a Face Shield

- Bend forward.

- Use two fingers on outer edges.
- Pull away from face and lift away.

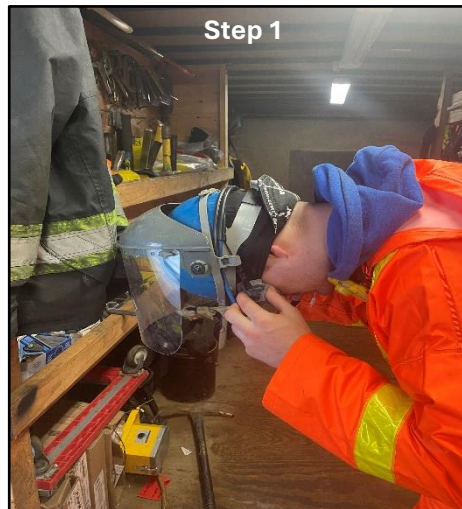
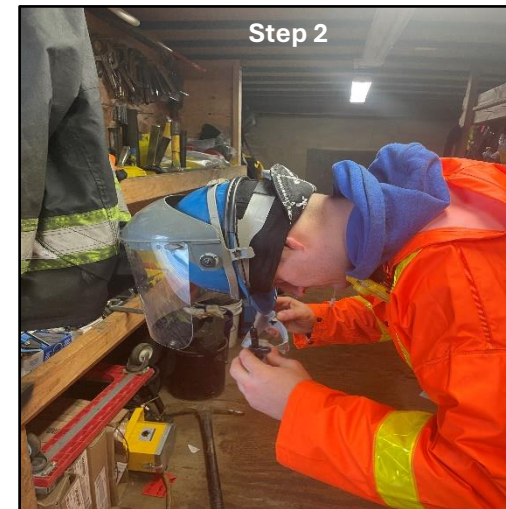
Removing Goggles and Full-Face Respirators

- Bend Forward

- Use two fingers on both outer edges.
- Close your eyes and exhale as you remove them.
- Pull away from face and lift away.

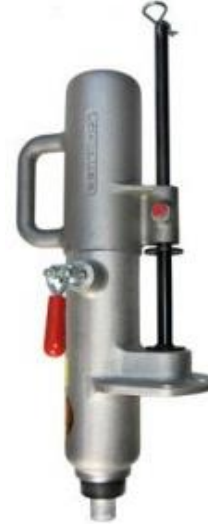
Step 1: Pull the Spring Plunger and lift top up.

Step 2: Set Aerosol can **upright** in the lower chamber

Step 3: Lower the top cover all the way until the Spring Plunger locks.

Step 4: To puncture, push the Red Handle down.

Hold down for a few seconds then slowly raise.

Let the can depressure and drain before removing.

Step 5: Remove can and **replace** top half to keep drum sealed.

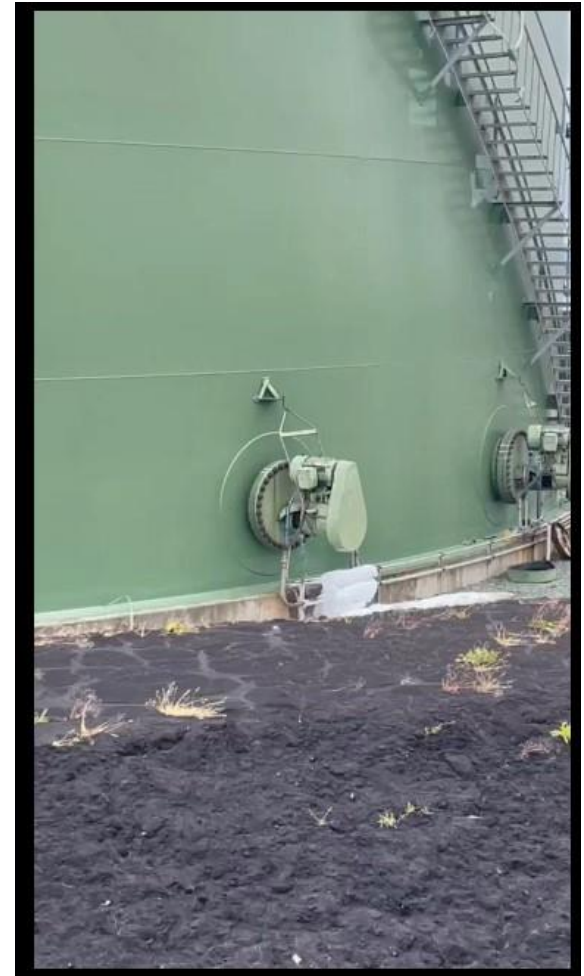
- On June 4th, 2024, at approximately 11:45 AM, a contractor was driving down the road and noticed material (“foam” like substance) in the Tank 231 yard.
- The contractor promptly notified operations who responded and observed a leak at the tank’s mixer seal. Operations, maintenance, and fire brigade responded. The road was barricaded, fire trucks were staged, and power was shut off to the tank yard. Machinists donned the proper PPE and back seated the mixer seal to stop the leak.
- There were no injuries.
- Due to the leak volume, estimated 1.47 bbl., this incident is a Tier 2 Process Safety Event.
- The tank remains in service with no mixers.
- No adjustment to the next out of service date of March 2040 has been made to replace mixers.
- A Category 2 investigation was initiated on June 17th, 2024

- Tank 231 had been in service since 1994, and the mixers were original equipment
- Mixers had been refurbished when tank was out of service for API inspection 2019-2020.
- MX-835 leaked in 2021. Investigation attributed the leak to shaft coating failure, being the original coating on the shaft.
- SP-43-15-TMI_CHKLIST includes a check of the mixer shaft for visible damage during mixer installation.
- RSP 1308 PSM/RMP Mechanical Integrity does not identify mixer service life.
- Vibrational analysis of mixers sometimes skipped if the mixer is not in operation during scheduled inspection.

Tank mixers were not replaced when the tank was out of service.

- The tank mixers were not replaced when the tank was out of service in 2019-2020. Both mixers eventually failed. Corporate guidance SP-47-05 notes reinstalling mixers utilizing checklist SP-43-15-TMI_CHKLST. Both mixers were refurbished and reinstalled according to maintenance records.
- The recommendation to replace mixers has been adopted informally by the tank group since TK231 was out of service in 2019-2020.
- MX-835 leaked in 2021 and cause was attributed to failure of shaft coating due to the service life of the mixer. Mixers were left in place with plan to replace shafts during next tank outage scheduled for 2040, Intellex recommendation 270318. The failure mechanism has not been determined for MX-853 that leaked June 4th, 2024 as the mixer cannot be removed to perform failure analysis while the tank is in service.

Rec 1: Update refinery guidance to require replacing mixers at the schedule service interval by adding to local tank outage checklist.

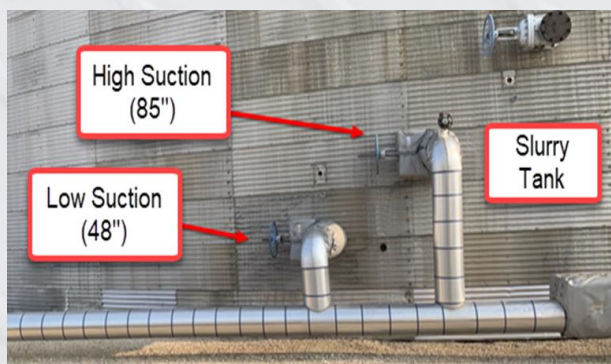
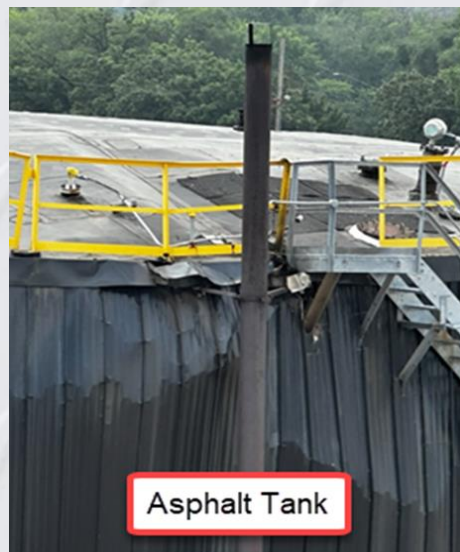
- On August 5, 2023, St. Paul Park (SPP) initiated the routine transfer of material between two blended pitch (asphalt) tanks. This asphalt transfer used a section of line that had previously been used for loading barges with slurry. During the barge loading, water from the slurry tank entered the transfer line section common to both activities. This common line was not cleared after the barge loading as specified in the operating guideline. Shortly after starting the asphalt transfer, water and slurry were pushed into the hot asphalt tank, which rapidly vaporized and damaged the roof.
- This incident was categorized as a PSE1 due to the direct costs (exceeded threshold of \$100,000) for repairing the tank.

- Floating free water was transferred out of the slurry tank via the high suction nozzle into the common transfer line.
- Approximately 1,700 feet of 8-inch piping (105 barrels) was not cleared after slurry barge loading and pushed into the hot asphalt tank.

“THE REST OF THE STORY”: Slurry barge loading was the source of the water and preceded the asphalt transfer that resulted in the event. During slurry barge loading, both the high suction and low suction valves were open at the slurry tank. Operations was aware of the concerns regarding catalyst accumulation in the bottom of the tank but were unaware of the free-floating water on top of the slurry. Previous RADAR rounds did not adequately measure or detect the free-floating water. Having both suction valves open and drawing the tank level below the high suction allowed this free water to enter the piping that is common to barge loading and asphalt transfer. At the conclusion of barge loading, the loading piping was cleared from the manifold to the barge using nitrogen, but not from the manifold back to the slurry tank. The decision to not clear the line back to the slurry tank was based on product quality considerations. Moving the small volume of slurry remaining within the common line (relative to the tank transfer volume) into the asphalt tank was thought to be inconsequential as the presence of water was still not known.

While inspecting the tank damage, it was determined that the stair platform was welded on to the frangible roof joint. When the tank failed, the wall started to buckle which could have resulted in loss-of-integrity of the wall and an uncontrolled release of liquid from the tank. The standard for building tanks states that the frangible joint cannot be welded on.

Update SP-90-13, Above Ground Storage Tank Inspection Program, to ensure no items are welded on top of or to the tank frangible roof joint that could limit its performance or opening when needed (such as a platform or stairs).	Kenny Spriggs	2/28/2026
