March 2026

Environmental, Safety & Security Sequential Safety Meeting

ANACORTES REFINERY

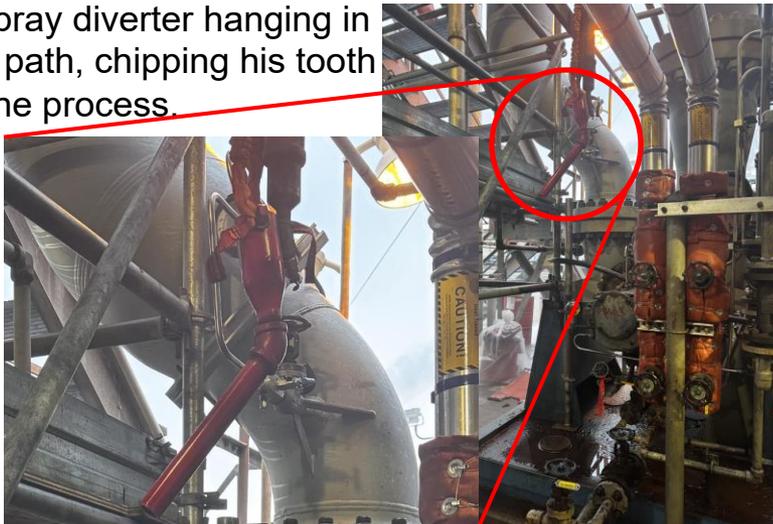
Mechanic sustains chipped tooth during maintenance

While installing a gage and tubing above P-5503, a worker was moving over the pump tray and contacting a spray diverter hanging in the path, chipping his tooth in the process.

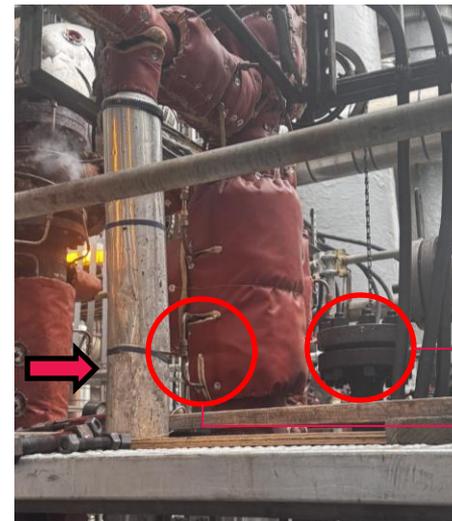
Flange
Steam tracing

Business partner burns face on steam trace
Oct. 20, 2025

While unbolting PSV-5505, a business partner squeezed between two pipes to reach a flange.

While leaning in, the worker was unaware of steam tracing on the pipe and received a burn to the left side of their face.

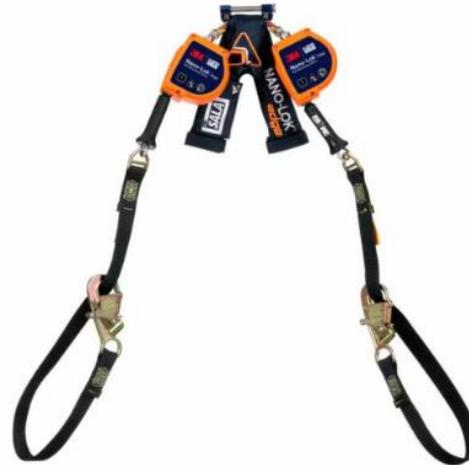
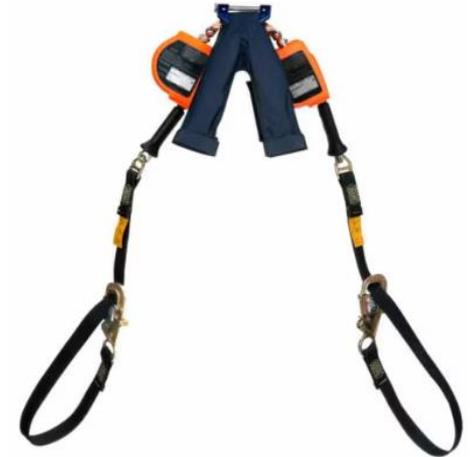
3M DBI-SALA Nano-Lok edge Tie-Back Personal SRL

Reorganized and clarified flow; added PFAS definition and training requirements; included explicit ANSI/OSHA compliance statement. Clarified Class 2 SRL-Ps as the standard equipment to reduce equipment selection errors.

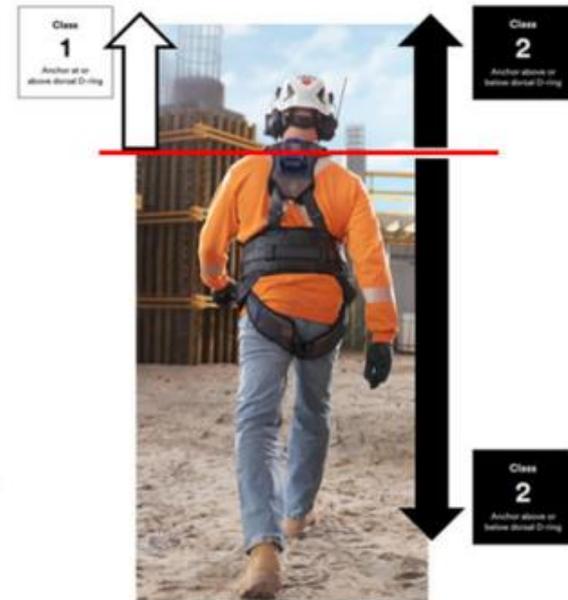
Class 2

- For use with anchorages ABOVE or BELOW the dorsal D-ring.
- Can be used when overhead anchorage is not feasible.
- Subject to a maximum free fall of 6 feet.
- Must be edge rated.

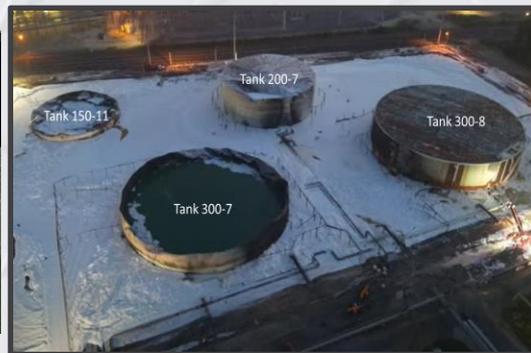
Tanks Post-Incident

Tank ID	Product	Inventory (Barrels)
150-11	Sour Naphtha	64,000
300-7	Ultra Low Sulfur Diesel	68,000
200-7	Gas Oil	10,000
300-8	Ultra Low Sulfur Diesel	API 653 Inspection (Out of service)

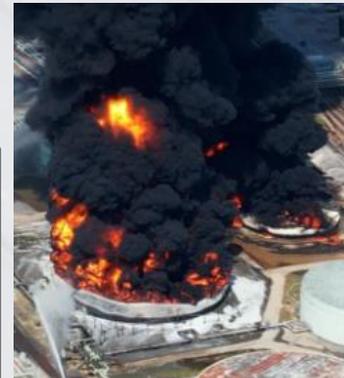
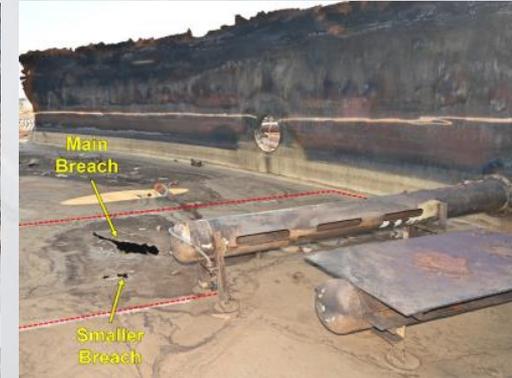
Tank 150-11 Post Incident

REST OF THE STORY: On Thursday, August 24, 2023, at 18:35, a tank farm Operator detected and witnessed a leak on Tk 150-11 (sour naphtha), between the inlet and outlet nozzles and the nearest manway. Soon after, tank farm operations start to de-inventory the tank by various means throughout the night. They started with 67,770 bbl. (23.18') of sour naphtha material and finished with 21,432 bbl. (7.33') at the time of ignition. Emergency Response Team (ERT) staged equipment and completely foamed the pool of liquid in the tank dike by 19:52. The foam blanket was maintained throughout the night. On Friday, August 25, 2023, at 06:31, the hydrocarbon vapors in the Tk 150-11 dike ignited with a flash in the southwest corner of the dike. The ERT became actively involved in fighting the fires with water and foam. At approx. 07:18-07:51, foam, water, and hydrocarbon overflowed the intermediate dikes between Tk 150-11 and Tk's 300-7 (ULSD) and 200-7 (Gas Oil), spreading the fire to these tank dikes. At approx. 08:45, both Tk 150-11 and Tk 300-7 became fully involved and engulfed in flames. On the night shift, Tk 200-7 received collateral damage (failed frangible joint) due to prolonged exposure to fire and heat. During the early morning hours on Saturday, August 26, 2023, a large flare-up event took place, and Tk 300-8 (an out-of-service ULSD tank) received collateral damage (a failed frangible joint) due to material entering the tank through an open manway and catching on fire. On Sunday, August 27, 2023, ERT personnel continued to fight fires/flare-ups as they popped up and quenched known hot spots as determined by IR camera images taken via drone. The fire and hot spots were finally extinguished/quenched on Monday, August 28, 2023.

- 1.) The open elbow conduit was the most likely source of the ignition based on the carbon residue inside the elbow and melted copper wires that showed signs of arcing.

- 2.) Coating in area of leak failed due to exposure to acidic water or improper metal preparation and/or coating installation in 2011. This allowed acidic water (pH on average of 4.4) to access the carbon steel floor plate. Carbon steel floor plate failed catastrophically due to acidic water corrosion. The acidic water was generated from the sour naphtha material being treated with a water soluble H2S scavenger at a point of off-site origin that had a starting pH range of 2.0-3.5. Testing and evaluations on the remaining coating appear to show the coating to be in good condition on the rest of the tank floor.

- 3.) It should also be noted that one of the internal water draw piping nozzles on the tank (designed to remove any water collection on the tank floor) had holes in the piping not allowing an effective and efficient way of removing the tank water bottoms. Plans are to redesign the internal water draw piping to increase its reliability. The GVL site was following all corporate and local procedures/policies for managing the tank water bottoms for pH and microbiological activity.
