# **Environmental, Safety & Security Sequential Safety Meeting**

**ANACORTES REFINERY**

# PSE1 MPC PROCESS SAFETY ADVISORY

## GALVESTON BAY REFINERY SOUR WATER TANK FIRE INC# 409438

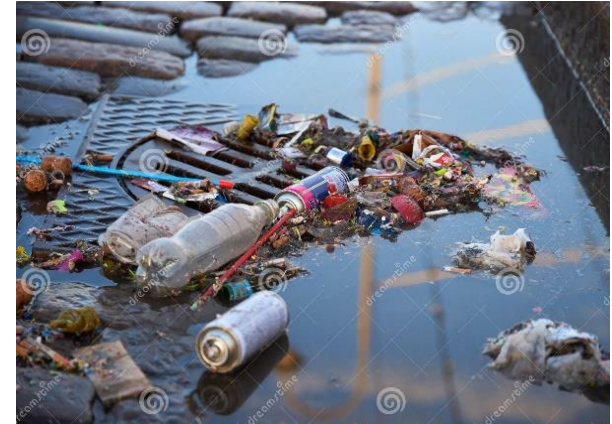
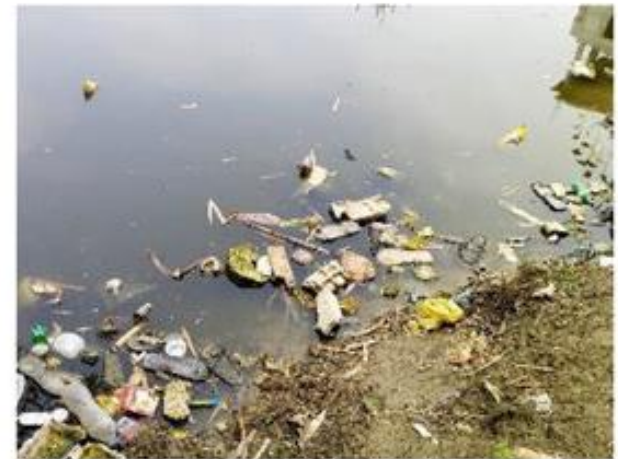
This is a reminder that any trash or litter on the ground could get swept into the sewer system and cause major problems:

- Sewer blockages
- API overflow – oil to ground/compliance issue
- Turning regular trash into hazardous waste - \$\$
- Trash could end up in Fidalgo Bay

\*Pictures are NOT from Anacortes Refinery

Please practice good housekeeping after rain/wind events and keep our refinery looking nice!

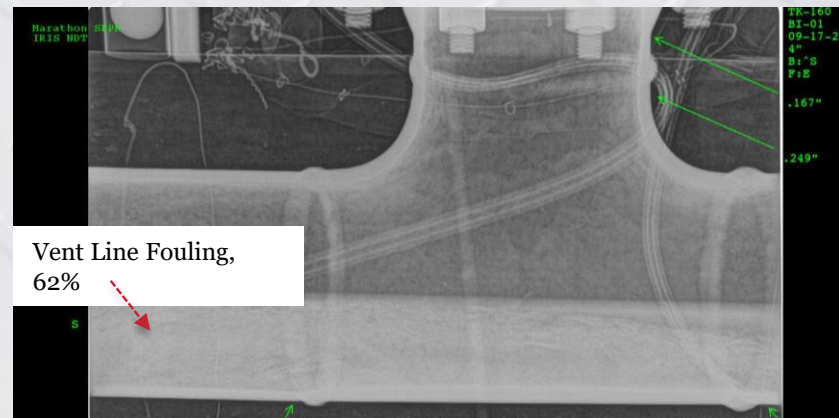
On September 14, 2024, the rupture disc on Sour Water Tank 160 burst and released to the atmosphere. Personal and fixed gas H<sub>2</sub>S monitors began to activate. Tank 160 nitrogen blanket flow could not restore pressure, so draw from the tank was reduced to prevent air ingress. Just prior to the release, a temporary FCC gasoline treating system had been started up. Due to a design issue, FCC gasoline was routed to the tank causing the high pressure.

**\*Recommendation included in GBR Global Recs in previous slide\*** Update SP-42-20 Tank Blanketing to include steam/heat tracing the vapor lines (including pilot lines) with a system that will keep the walls of the entire piping circuit greater than 212°F to prevent condensation of water vapor on the inside of the pipe for tank blanketing systems to a closed vapor recovery system on tanks with high H<sub>2</sub>S concentrations in the vapor space (i.e., Sour Water Tanks).
