Environmental, Safety & Security Sequential Safety Meeting

ANACORTES REFINERY

**Debutanizer Feed Line Pinhole Leak:
Abrasive Blasting on Live Equipment
B-Zone – Gas Recovery**

**Cat 2 Investigation: Incident #507866
12/31/2025**

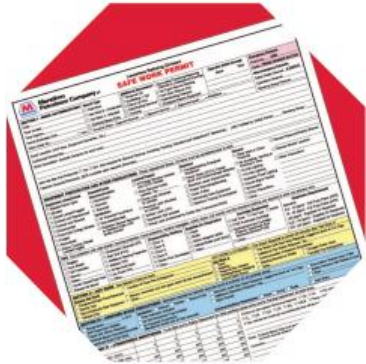
Communication & Closeout Compliance

- Several audited permits were missing Owing Department Channel in Section 1.
- 12 of 13 closed CSE permits reviewed were missing CSE debriefing information.

- Delays emergency response if correct contact info is missing
- Debriefs capture lessons learned and hazards encountered

- In section 1 of permit, include both Owing Department and Servicing Group contact.
- Complete CSE debrief section for every CSE permit.
 - Document issues, hazards, or deviations
 - Confirm work conditions at completion.

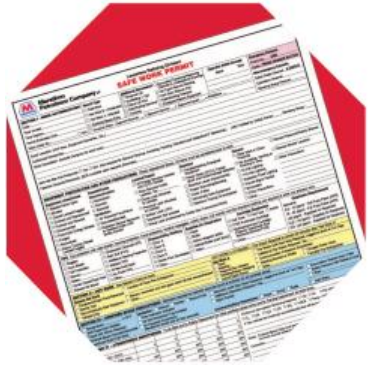
Confined Space Permit Accuracy

- One permit was used for multiple confined spaces (entry into two separate manholes)

- Each confined space has unique hazards and atmospheric conditions. Separate permits ensure each space's conditions are properly covered.
