March 2025

Environmental, Safety & Security Sequential Safety Meeting

ANACORTES REFINERY

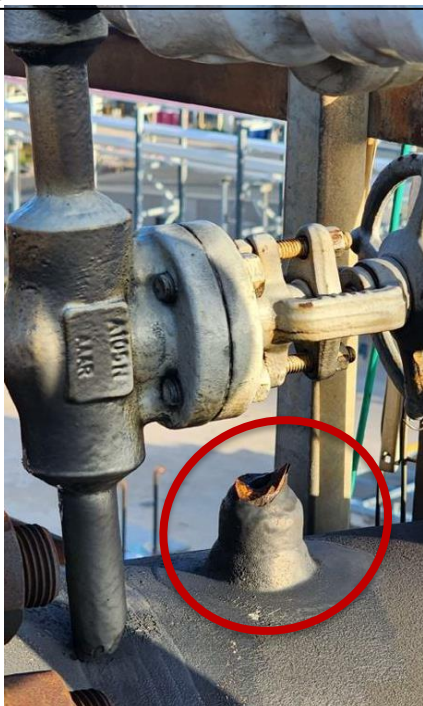
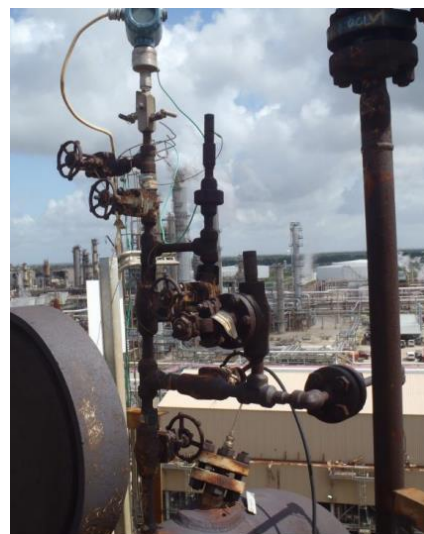
Original piping tree prior to replacement

~100' piping to H2 analyzer at grade

(GBR) On August 11, 2023, a failure occurred on an unsupported $\frac{3}{4}$ " pipe nipple welded to a 14" overhead line of the GBR Cat Feed Hydrotreating Unit's (CFHU) High Pressure Monoethanolamine (MEA) Tower. The failed $\frac{3}{4}$ " pipe nipple connects an overhead pressure transmitter and H2 analyzer to the 14" overhead line. The pressure transmitter is located directly above the vessel, while the H2 analyzer is at ground level, approximately 100' below the piping connection.

- The piping tree weight increased when replaced with schedule XXS (0.312" thickness) from original piping schedule 160 (0.219" thickness). A stress analysis was not performed to determine the additional support needs of the cantilevered piping.
- A MOC was not performed to assess the hazard or document changes made to the piping tree during the October 2022 turnaround.

The $\frac{3}{4}$ " pipe tree had been replaced during the 3rd Quarter 2022 CFHU Turnaround with the intent to replace the piping in kind. The original piping was fabricated with schedule 160 components (0.219" thickness), and the MPC Core Line Class Specification (G2AV) also specified the use of schedule 160 components. However, the new branch piping was fabricated using schedule XXS components (0.312" thickness). This included the 100 ft run of pipe from tower overhead to grade, increasing the weight by 54 lbs. A management of change (MOC) was not entered to document these changes, and a stress analysis was not performed to evaluate if the new pipe tree needed pipe supports. Due to the lack of pipe supports and material thickness change, the branch piping was subject to a fatigue failure mechanism, which was validated by a metallurgy lab post-failure. Supports were added to the branch piping to prevent vibration and fatigue.

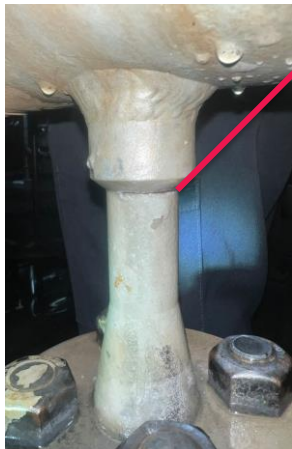
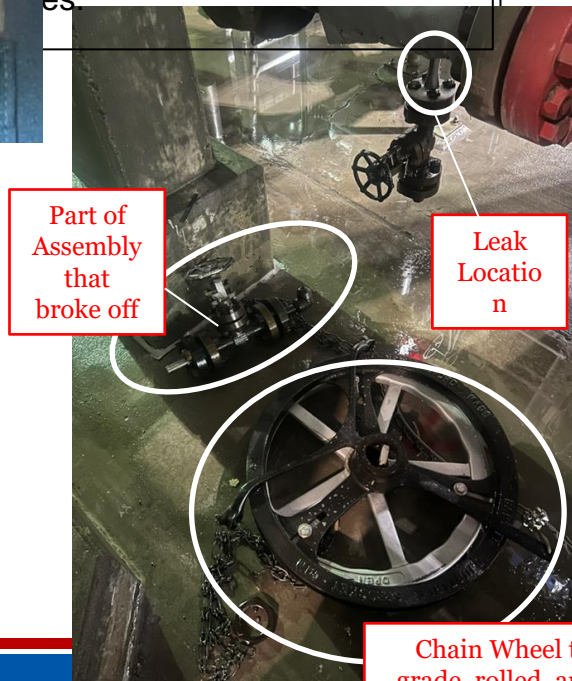
Part of
Assembly
that
broke off

Leak
Location

(SLC) On October 28, 2023, a loss of containment event occurred on the SLC Distillate Hydrotreater Unit (DHT) resulting in a PSE 1. Severe vibrations, caused by a chattering high pressure separator level control valve (LCV-260414), resulted in fatigue cracks on the bleeder valve upstream of LCV-260414. The vibrations also caused a chain wheel assembly to fall and contact the same bleeder valve upstream of LCV-260414. The cable restraint on the chain wheel assembly was not attached. The combination of the fatigued welds and contact from the chain wheel assembly opened the crack large enough to cause loss of containment.

- The failed welds were analyzed and found to have signs of metal fatigue and some rust which indicates that the cracks in the weld were not caused solely by the events on 10/28/2023 but began before that. It is believed that that severe vibrations on 10/28/2023 caused the existing cracks to grow larger.
- The small-bore bleeder piping was built with double block valves. Due to the high-pressure rating of the piping, the flanges are very heavy and put a lot of stress on the elbow and piping connections. This design is subject to fatigue failure through the course of its life due to a long, unsupported lever arm.
- Severe vibration in the piping was observed by the operators as LCV-260414 was rapidly opening and closing. It is believed that the rapid cycling of LCV-260414 was the source of the vibration.

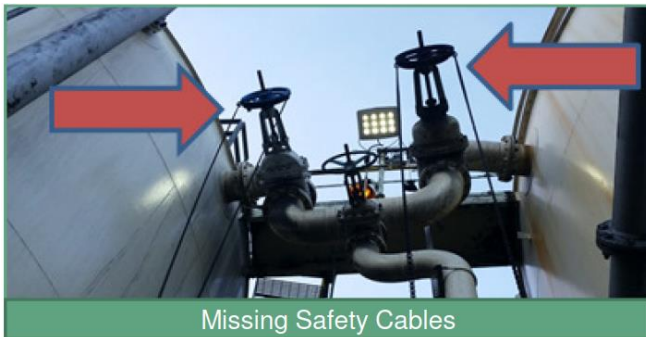
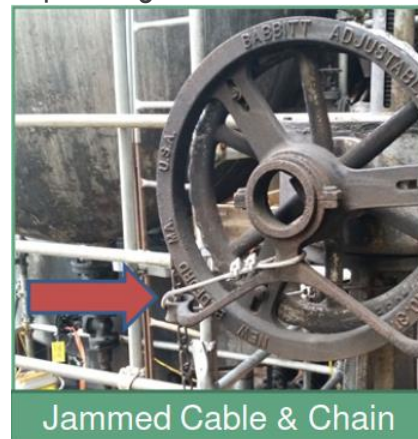
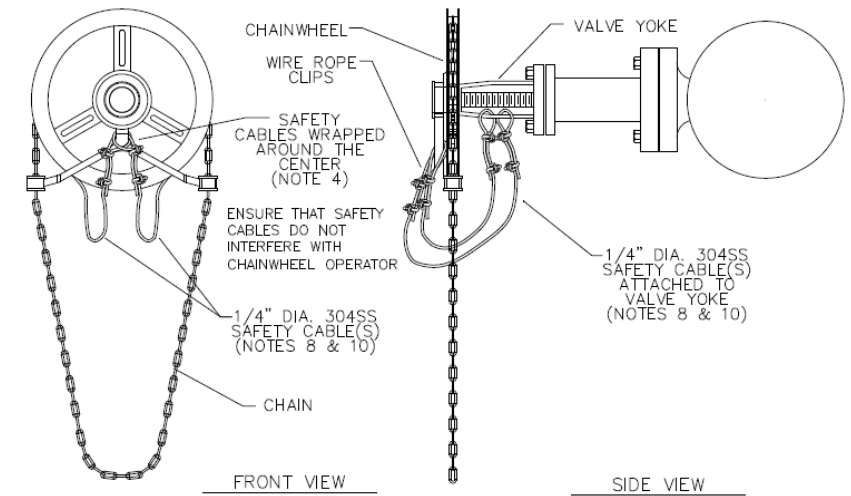
IMPORTANT: WHEN TWO CABLES ARE REQUIRED, ONE OF THEM SHALL HAVE A 4-INCH DIFFERENCE IN INSTALLED LENGTH.

VALVE HANDWHEEL SIZE/VALVE SIZE	MATERIALS (QTY)
HANDWHEEL DIA. ≤ 19 IN. AND VALVES ≤ NPS 10	(1) 1/4" DIA. X 76" LG. 304SS (60" 7 X 19 CABLE CORE CONSTRUCTION); (4) 1/4" TYPE 316SS WIRE ROPE CLIP; BABBITT SKIT-0 OR ROTO HAMMER RCK-1/4 (NOTES 11 & 12)
HANDWHEEL DIA. > 19 IN. OR VALVES > NPS 10	(1) 1/4" DIA. X 76" LG. 304SS (60" 7 X 19 CABLE CORE CONSTRUCTION); (1) 1/4" DIA. X 72" LG. 304SS (60" 7 X 19 CABLE CORE CONSTRUCTION); (8) 1/4" TYPE 316SS WIRE ROPE CLIP
ALL VALVES WITH A HAMMER BLOW DEVICE	BABBITT SKIT-4R OR ROTO HAMMER RCK-1/4 (NOTE 12)

- First check your position. Ensure you're not in the line of fire.
- Is chain wheel properly secured? Is hardware tight, nothing missing or visibly loose?
- Is the safety cable in place?
- Is the cable secured in proper location, routed through both chain guides, and not jammed or tangled?
- Does it have 2 cable clamps on each end, and are they installed correctly, with the nuts of the clamp on the long end of the cable?
- Is wheel sprocket intact (no cracks or missing parts) and properly centered so it will operate well?
- Is chain long enough to operate safely? Are you able to stand to the side while operating it to stay out of the line of fire?
- Does the chain show any signs of damage?

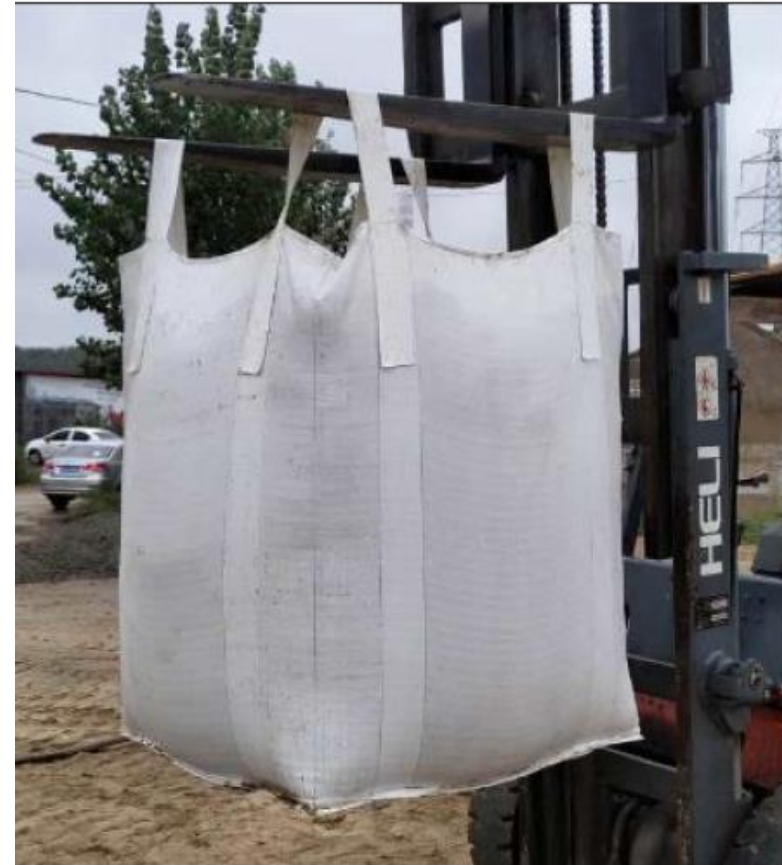
- While reviewing a Refining Bulletin on Super Sack Lifting Loop Failure from an Incident at our Robinson Refinery on September 10, 2024, he noted in this photo that it shows using a forklift to lift the supersack. We should never hang anything directly from the forks of a forklift. The forks have a sharp edge; movement can cut or burn the straps causing them to fail.
- Contact Safety Department with any question or concerns.
