**May 2025**

# **Environmental, Safety & Security Sequential Safety Meeting**

**ANACORTES REFINERY**

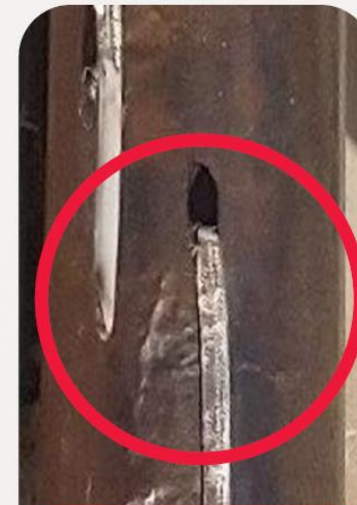
Damaged Electrical Heat Trace from an Angle Grinder

Date	Location	Details
1/15/25	DET	Electrical Heat Trace Wires Cut for NDT
11/18/24	MAN	Angle Grinder damages Electrical Heat Trace
10/9/24	KEN	Electrical Heat Trace Damage on Recovery Well
5/29/24	ROB	Damaged Electric Tracing (photo)
5/22/24	MAN	Electric Heat Trace Cut on V-2012 DDU
3/30/24	DET	Shocked Received while Operating Valve
10/30/23	ROB	Cut and Abandoned Electric Heat Trace Cable Arcs

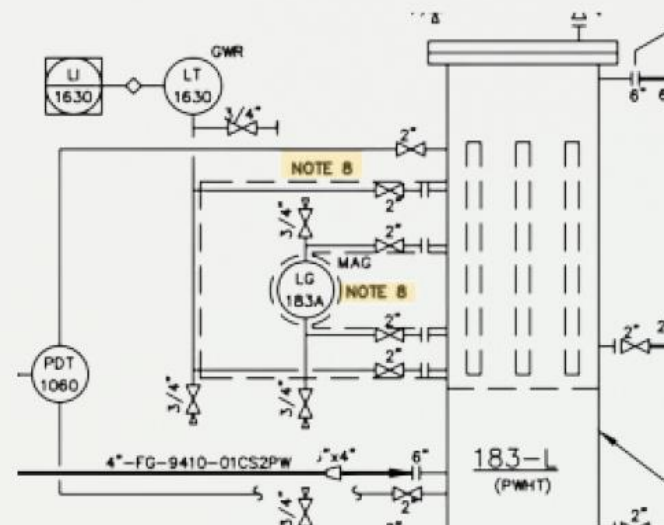
1. FOR SYMBOLS, GENERAL NOTES, AND STANDARD DETAILS, SEE DRAWING B-2200-1/65/66/67.
2. METER RUNS SHALL BE PRECISION TYPE PURCHASED FROM ORIFICE PLATE VENDOR.
3. VALVE STEM SHALL BE IN THE HORIZONTAL POSITION.
4. PROVIDE BREAKOUT SPOOL FOR MAINTENANCE.
5. GLOBE VALVE.
6. LOCATE CHECK VALVE NEAR RICH AMINE HEADER.
7. ALL INSTRUMENT CONNECTIONS ARE 300# 03CS-2PW.
8. ELECTRIC HEAT TRACE AND INSULATE.
9. GLYCOL FILL.

- Review P&ID's to identify electric heat traced equipment:
  - Piping and Tubing
  - Vessels
  - Pumps
- Walk piping circuits and other equipment to identify electric heat trace labels, power connection and end kit boxes
- Involve E&I Planners to identify the power circuits
- Ensure the work scope is agreed upon by craft and Operations
- LOTO

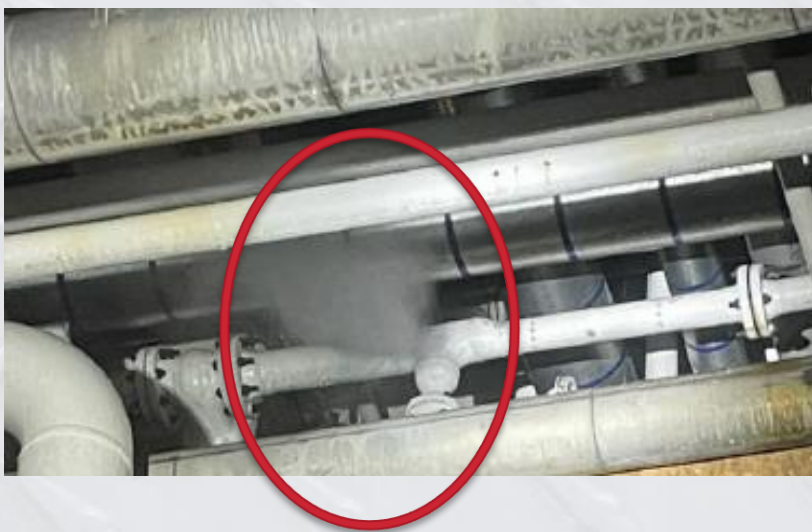
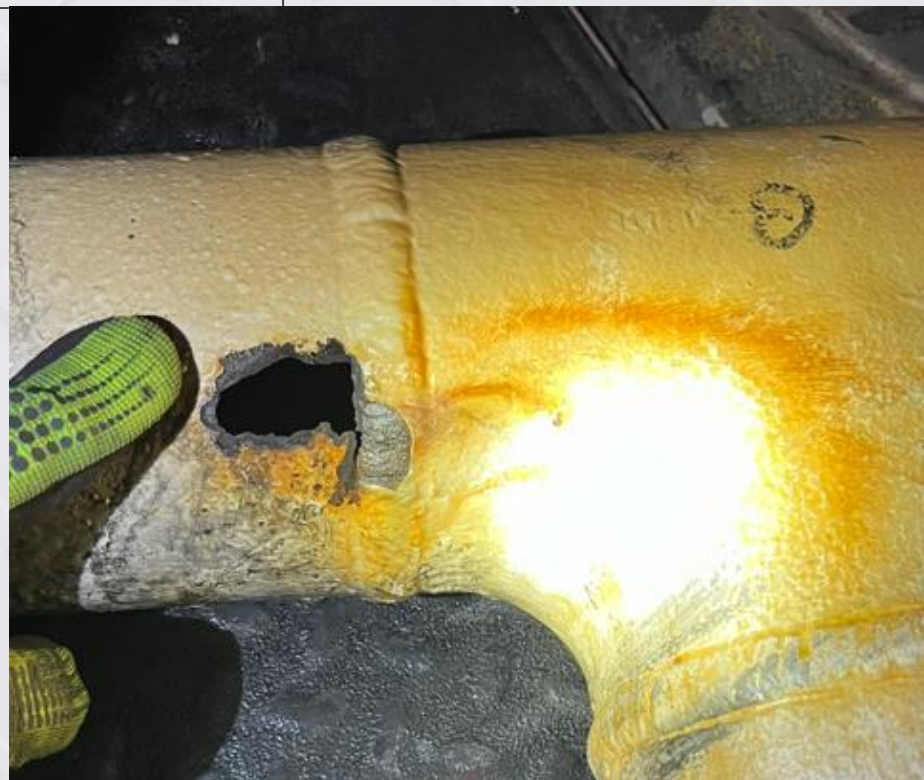
On November 5, 2023, a leak developed in the Outside Battery Limits (OSBL) pipe rack on a liquid charge line to the Saturate Gas units. The leak occurred at the mix point of the Crude and Ultraformer Debutanizer overhead liquid product streams.

- Corrosion was caused by a combination of two factors:
- Increased Ultraformer chlorides due to continuous perchloroethylene injection installed in 2022 and lack of chloride treatment system.
- Chlorides from the Ultraformer encountered excess free water from the Crude Debutanizer and caused accelerated mix point corrosion.

**“THE REST OF THE STORY”:** The chlorides in the system increased in 2022 when an online perchloroethylene injection was installed. The purpose of the injection is to increase catalyst activity in the Ultraformer reactors. Chlorides carrying through the liquid phase result as free Hydrochloric Acid (HCl) in the hydrocarbon stream entering the Debutanizer system, ending up in the overhead circuit. No chloride guard bed is present to protect the Ultraformer Debutanizer. On its own, this HCl will not cause corrosion as it needs to be combined with water. However, this stream combines with the Crude Debutanizer Overhead liquid product enroute to the Saturate Gas unit for further processing. The crude stream contains excess free water due to separation constraints and operational changes over the years. The combination of HCl and free water led to accelerated mix point corrosion at the piping junction, resulting in a loss of containment. Site upgraded metallurgy and increased inspection until project to install chloride guard bed is completed in coming years.

An inspection grid was laid out on the mix point, but it was discovered to be in the wrong location (upstream, rather than downstream). How does your site ensure inspection grids are implemented at mix points to ensure representative hazard monitoring?
