February 2026

Environmental, Safety & Security Sequential Safety Meeting

ANACORTES REFINERY

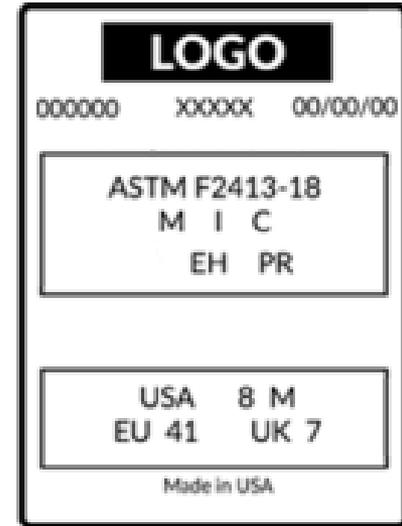
All footwear must be in compliance with OSHA Standard 29 CFR 1910.136.
This applies to all work in process areas, maintenance areas, lab, and warehouse.

Check the tag on the footwear. It must have the following information:

- ASTM Standard (ex. ASTM F2413)
- I (Impact protection)
- C (Compression protection)
- EH (Electrical hazard) or SD (Static Discharge)
- PR (Puncture resistant)
 - A PR insole may be used if the tag does not have a PR rating

Additionally, footwear must have a defined ¼” heel, slip resistant soles, and cover the ankle. Slip on footwear are authorized as long as they meet the above requirements.

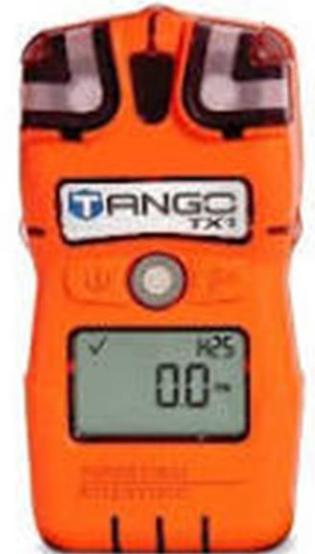
This month the 'chirp function' was programmed into the Tango monitors. This is an engineering control that should serve as an effective reminder to calibrate our tango monitors every month as required by RSP-1701.

THINGS TO REMEMBER REGARDING H2S MONITORS:

- H2S monitors are required whenever you enter a process area
- If you dock your monitor, wait for it to finish before entering a process area
- Monitors must be docked every 30 days **AT A MINIMUM**
- Your H2S monitor may be the only thing warning you of a potentially life threatening atmosphere

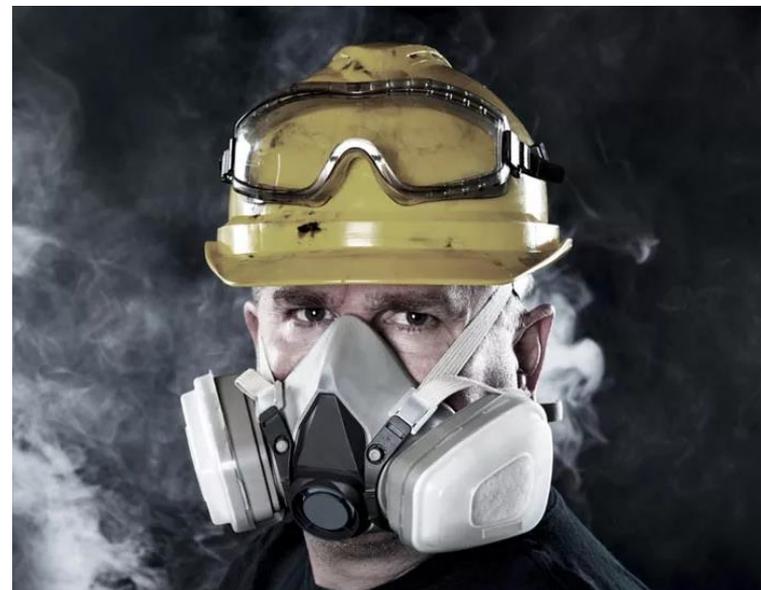
Respirator Selection

When working with airborne hazards, respiratory protection shall be set based on the PEL of the particular airborne hazard.

Attachment 1 of the Respiratory Protection Program document (R-14-008) outlines which respiratory protection is appropriate for a given hazard. Some examples from the chart are below.

Type of Hazard	Degree of Anticipated Hazard or Situation of Use	Respirator to be Used (terms defined at end of table)
Ammonia	Sampling, blinding	Full-face with lime green or olive drab cartridges
Hydrocarbons (< 0.1% Benzene)	Moderate leak of volatile hydrocarbon, or air concentration of <1000 ppm	Half-mask or full-face with organic vapor cartridge
	Air concentration <5000 ppm	Full-face with organic vapor cartridge, or Airline
	Tank or vessel entry before it has been cleaned of hydrocarbons, or air concentration greater than 5000 ppm	SCBA or Airline with escape bottle
Hydrogen Sulfide	Air concentration from 0-9 ppm	None
	Air concentration from 10-49 ppm	Supplied Air, APR if approved
	Air concentration from >50 ppm	Supplied Air
Unknown Atmosphere	Entry into confined space or other anticipated hazardous atmosphere where hazard level is unknown	SCBA or airline with escape bottle

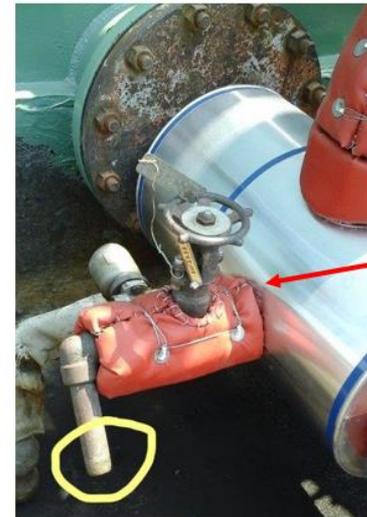
What is an Open Ended Line (OEL) ?

<p>OPEN VALVE</p> <p>CLOSED VALVE</p>	<p>OPEN TO ATMOSPHERE OR OPEN DRAIN</p>	OEL
	<p>CLOSED VALVE</p> <p>OPEN VALVE</p>	<p>OPEN TO ATMOSPHERE OR OPEN DRAIN</p>	OEL
	<p>CLOSED VALVE</p>	<p>OPEN TO ATMOSPHERE OR OPEN DRAIN</p>	OEL
	<p>CLOSED VALVE</p> <p>CLOSED VALVE</p>	<p>OPEN TO ATMOSPHERE OR OPEN DRAIN</p>	NOT OEL
	<p>CLOSED VALVE</p> <p>CAP/PLUG/ BLIND FLANGE</p>		NOT OEL
	<p>OPEN VALVE</p> <p>CAP/PLUG/ BLIND FLANGE</p>		NOT OEL
	<p>OPEN VALVE</p> <p>PI</p>	<p>PRESSURE GAUGE OR OTHER INSTRUMENTATION</p>	NOT OEL
	<p>OPEN VALVE</p> <p>PLUG</p>		NOT OEL

Open-ended valve or line means any valve, except safety relief valves, having one side of the valve seat in contact with hydrocarbon process fluid and one side open to the atmosphere.

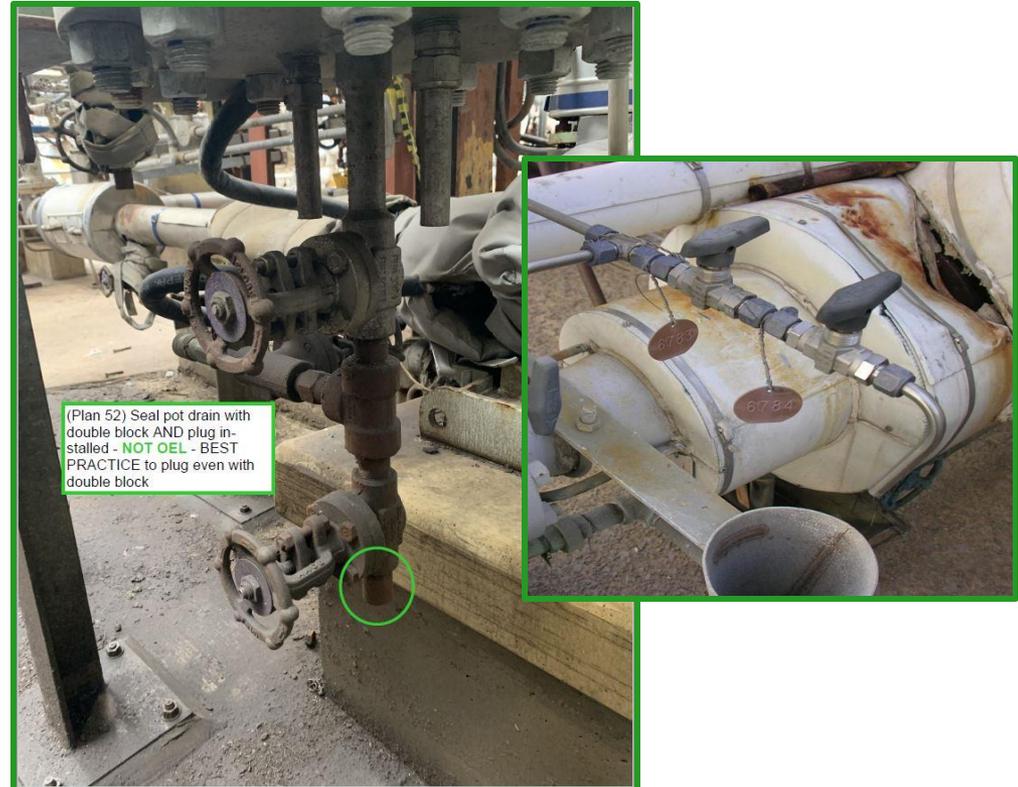
§ 60.482-6a Standards: Open-ended valves or lines.

- Each open-ended valve or line shall be equipped with a cap, blind flange, plug, or a second valve
- The cap, blind flange, plug, or second valve shall seal the open end at all times except when operations require the valve to be opened, such as draining or venting. **The cap, blind, or plug should be replaced, or the 2nd valve closed immediately afterward.**
- Each open-ended valve or line equipped with a second valve shall be operated in a manner such that the valve on the process fluid end is closed before the second valve is closed. **Ensure no process fluid is trapped between the two valves.**

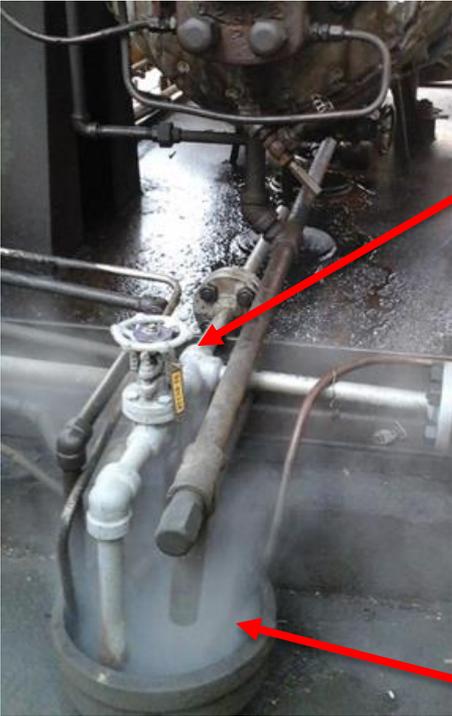
Needs Cap

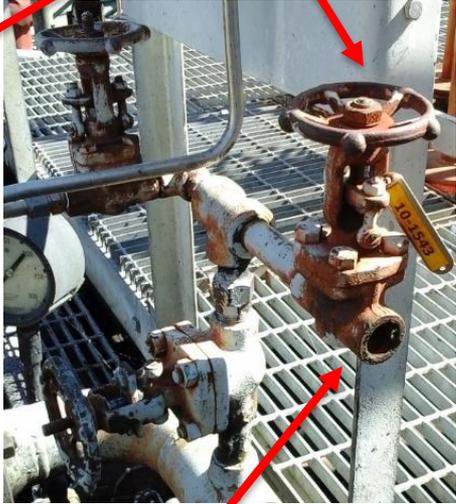
Only one isolation point – these are all OELs

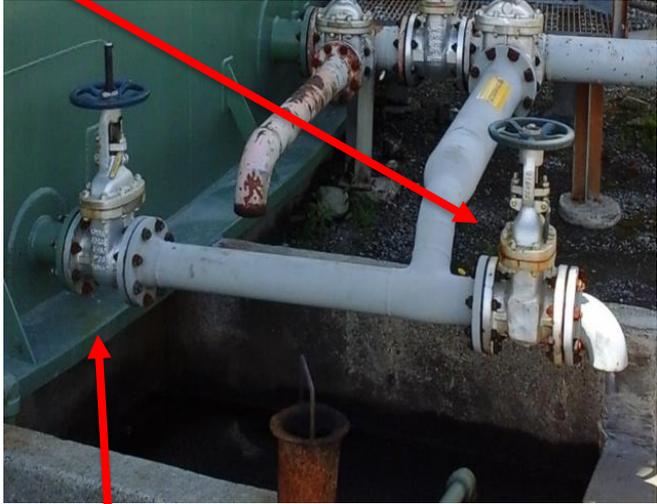
Needs to be closed or 2nd block valve added

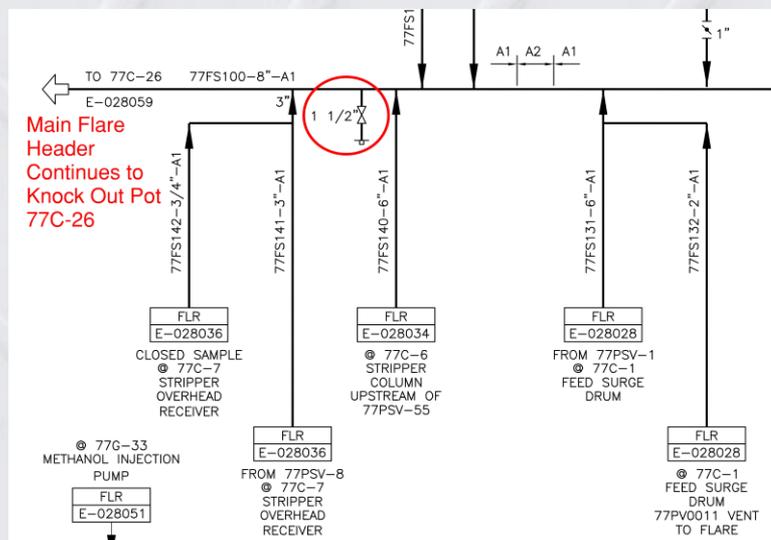
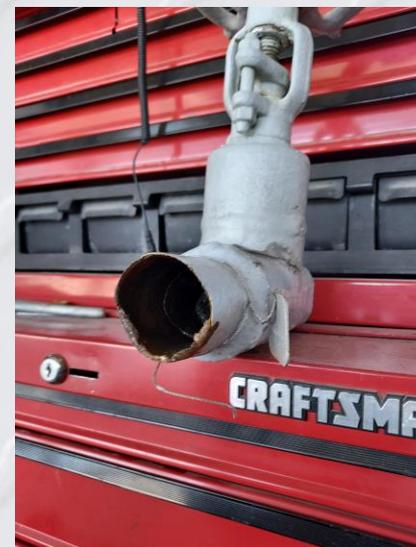
ROBINSON REFINERY PENEX FLARE LINE LEAK INC # 435493

On July 6, 2024, a leak developed on the flare line of the refinery's Penex Unit at the location of a nominal pipe size (NPS) 1 1/2" low point bleeder.

- Hydrogen Chloride (HCl) carryover to the flare system combined with water resulting in acidic conditions leading to corrosion and failure of a low point bleeder.
- A radiograph inspection taken in 2016 incorrectly listed the piping as "schedule 40" and not the actual installed schedule 80, resulting in a false reduced corrosion rate.

“THE REST OF THE STORY”: The Robinson Penex is an isomerization unit that utilizes chlorides to facilitate the reaction process. The chlorides are primarily removed via the Stabilizer Overhead System. In 2008, a new sample station was installed on the off-gas stream. Venting this station routinely sends small amounts of chlorides to the unit’s flare header. Process upsets and shutdowns involving PSV relief or reactor depressurization resulted in streams containing chlorides being flared. The piping configuration of the flare header includes a NPS 1 ½ low point bleeder upstream of the knockout drum that served as a location for chlorides to pool. Historically, the flare header was purged with nitrogen following a de-pressuring event, but liquid freeing low points was not a common practice.

On August 25, 2016, a radiograph inspection was taken on the low point bleeder and pipe nipple. The inspection showed a pipewall thickness of 0.151“, and this was assumed to be schedule 40 (0.145" wall thickness for NPS 1 ½” pipe). This resulted in zero wall loss from the nominal thickness. The next inspection interval was set for 10 years per API 570. The NPS 1 ½” piping was actually schedule 80 (0.200" wall thickness) when installed. This was discovered based on the original spec when the unit was built. The reading that was taken in 2016 was also backdated and entered as the 2006 reading resulting in zero corrosion rate from 2006 to 2016.
